***Railroad Corridor & Barrow Pit/Wetland***

## Railroad Corridor & Barrow Pit/Wetland

### Introduction

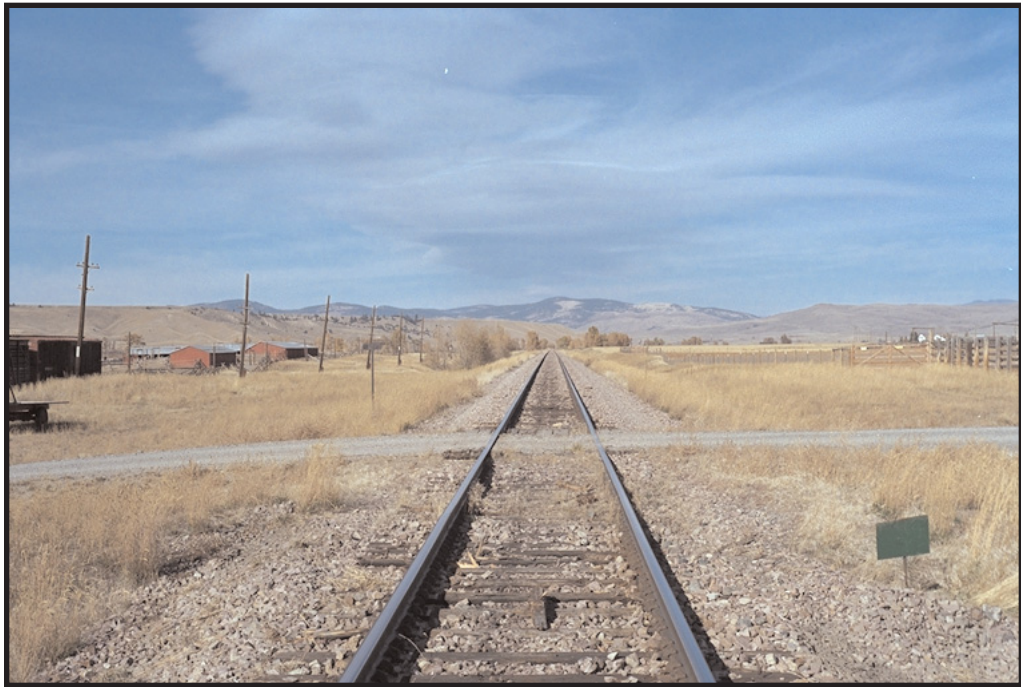
The railroad beds are elevated above grade for most of their length, except at road crossings located near the home ranch and northern boundary where they are at grade (see Photo 3-8-1). Each bed is approximately 10 feet wide and separated by an average of 75 feet throughout most of the park, although this area expands to over 140 feet near Cottonwood Creek. This is a depressed area that functions as a drainage swale for the two beds.

Photo 3-8-1 : (C-22) The railroad beds are elevated above grade for most of their length, except at road crossings located near the home ranch and northern boundary where they are at grade.

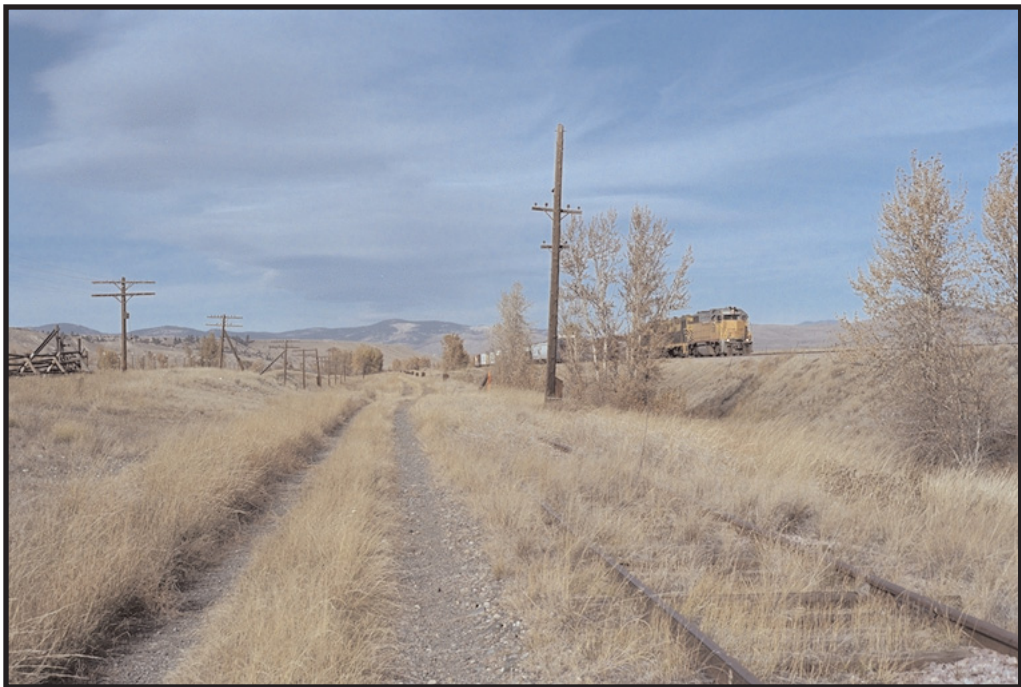
The Burlington Northern Railroad bed is elevated approximately 10 feet higher than the Milwaukee Railroad bed throughout most of the ranch (see Photo 3-8-2). These beds consist of sand and gravel fill material taken from the barrow pits; additional fill material was likely taken from other borrow areas off the ranch, although the source and composition of this material is not known.

Photo 3-8-2 : (D-01) The Northern Pacific Railroad bed is elevated approximately 10 feet higher than the Milwaukee Railroad bed throughout most of the ranch.

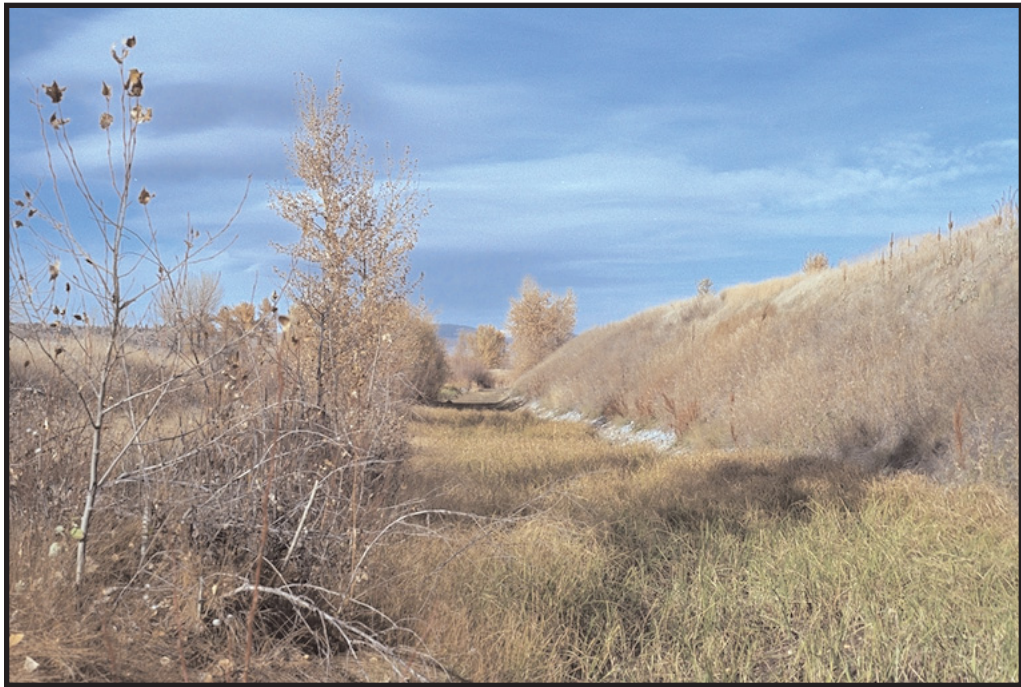
The barrow pits are deep pits that are lower in elevation than their surrounding landscape, and the banks of the railroad beds rise steeply up along their sides (see Photo 3-8-3). This is more noticeable in the western pit, as it appears deeper. These pits are now considered wetlands and standing water is evident in these areas.

Photo 3-8-3 : (E-04) The barrow pits are deep pits that are lower in elevation than their surrounding landscape, and the banks of the railroad beds rise steeply up along their sides.

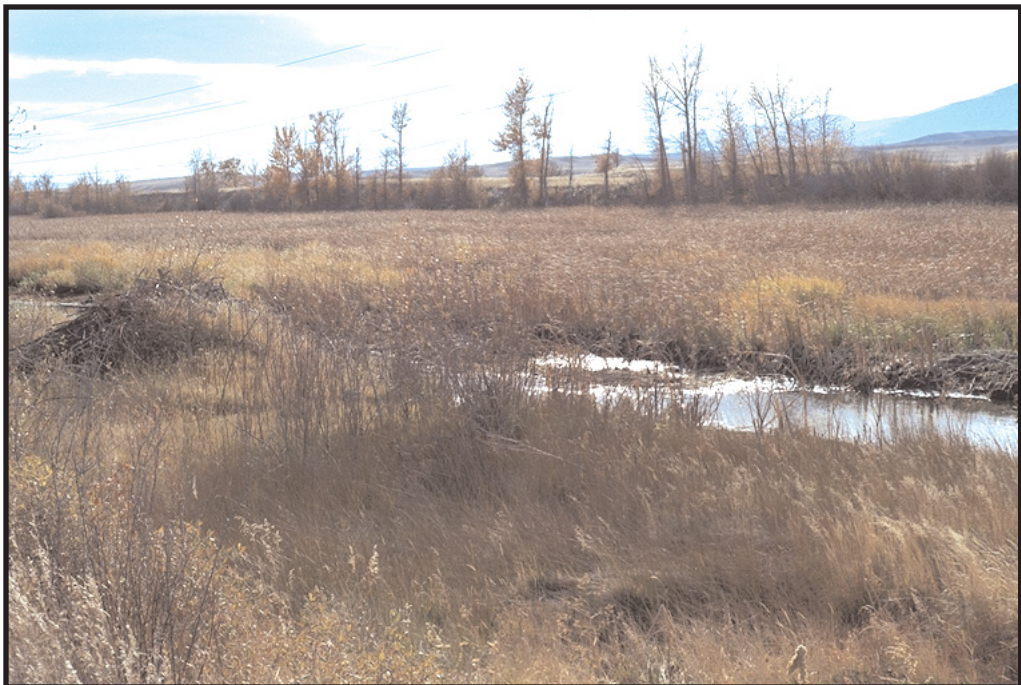
The beaver, in particular, has found conditions within these pits and many other areas within the riparian corridor ideal for colonization. Several beaver lodges have been constructed within these areas and are visible from Ranch roads (see Photo 3-8-4). This big-toothed, water-loving creature plays a significant role in the ecological history of the Clark Fork River valley, as well as the cultural history associated with the Ranch itself. Beaver are believed to have inhabited the

Photo 3-8-4 : (E-01) Wetland conditions are found within the barrow pits. A beaver lodge can be seen at left.

It is recommended that more research be conducted on the associated impacts, both positive and negative, of beaver colonization in preparation of Part II of this CLR, particularly as these impacts relate to the stabilization of the river corridor and mitigation of water quality.

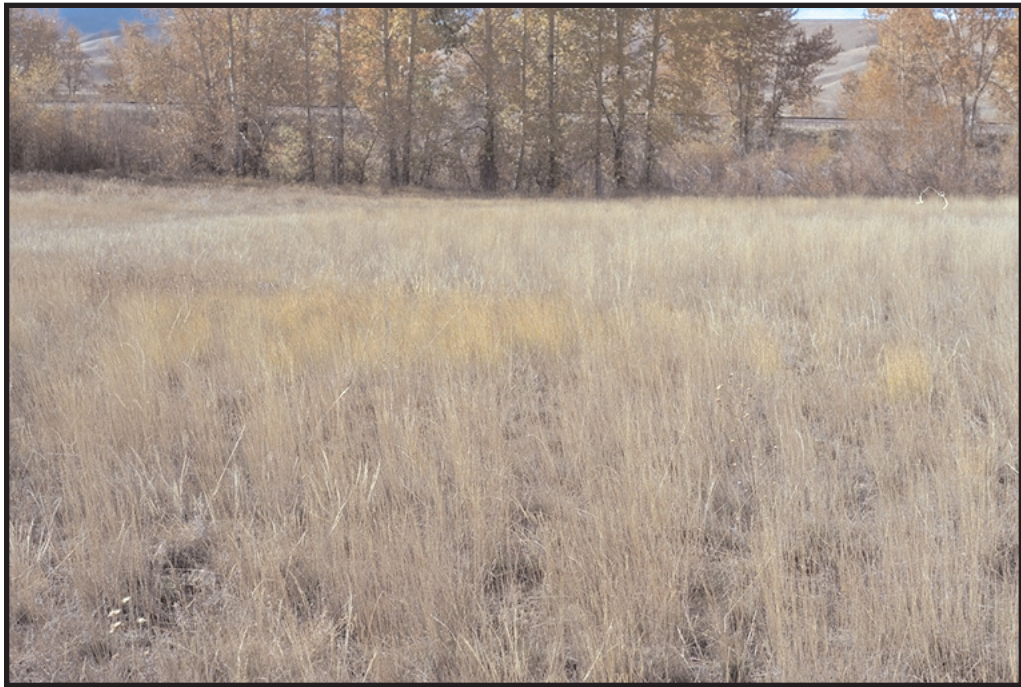
A concentration of native grasses are found in a small area adjacent to the eastern barrow pit, which remains fenced off from the pasture land found in the Front Fields (see Photo 3-8-5). The 1984 vegetation study conducted by Peter Rice and Gary Ray found this area to contain bluebunch wheatgrass, giant wildrye, and needle-and-thread grass, as well as other grasses and forbs that represent the native Montana inter-mountain prairie community, such as Indian ricegrass (*Oryzopsis hymenoides*), moss phlox (*Phlox muscoides*), long-leaf phlox (*Phlox longifolia*), upland larkspur (*Delphinium nuttallianum*), woolypod milkvetch (*Astragalus purshii*)

Photo 3-8-5 : (C-16) A concentration of native grasses are found in a small area adjacent to the eastern barrow pit, which remains fenced off from the pasture land found in the Front Fields.

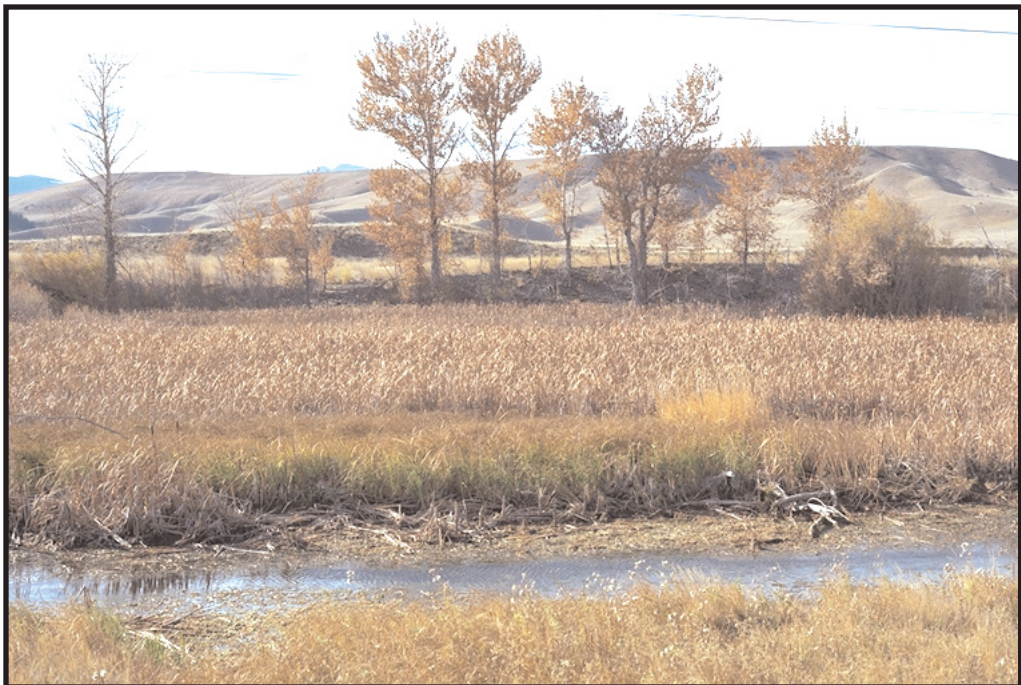
Photo 3-8-6 : (E-02) Cattails and other wetland plants, as well as cottonwoods and willows can be found within the barrow pits.

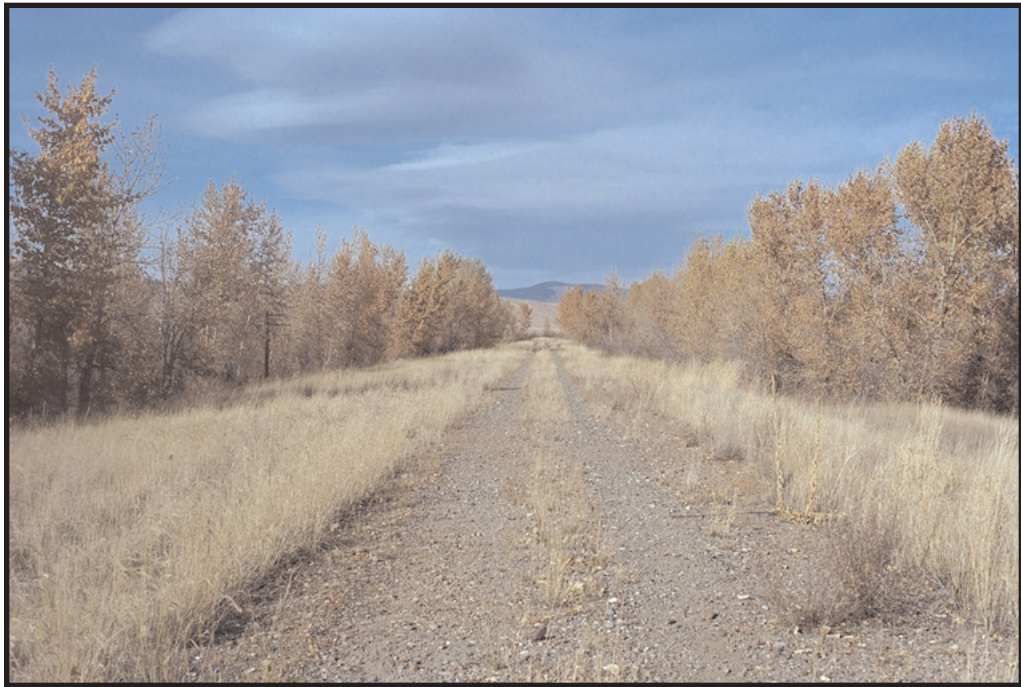
Photo 3-8-7 : (D-22) Vegetation along the rail corridors create “tunnel” views in some areas.

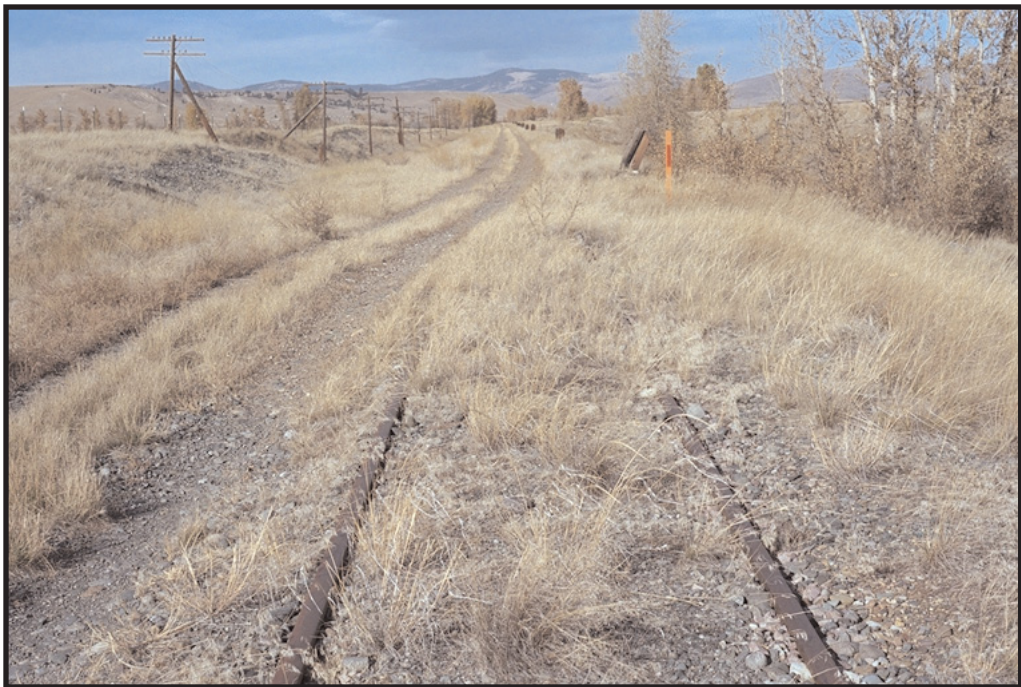
One dirt road runs parallel to the old Milwaukee Railroad bed, where it continues until the area where the tracks have been removed (near the L-Barn, HS-13). Here it shifts and continues over the abandoned rail bed corridor (see Photo 3-8-8).

Photo 3-8-8 : (D-02) The Milwaukee Railroad bed was constructed in 1908, and abandoned in 1983.

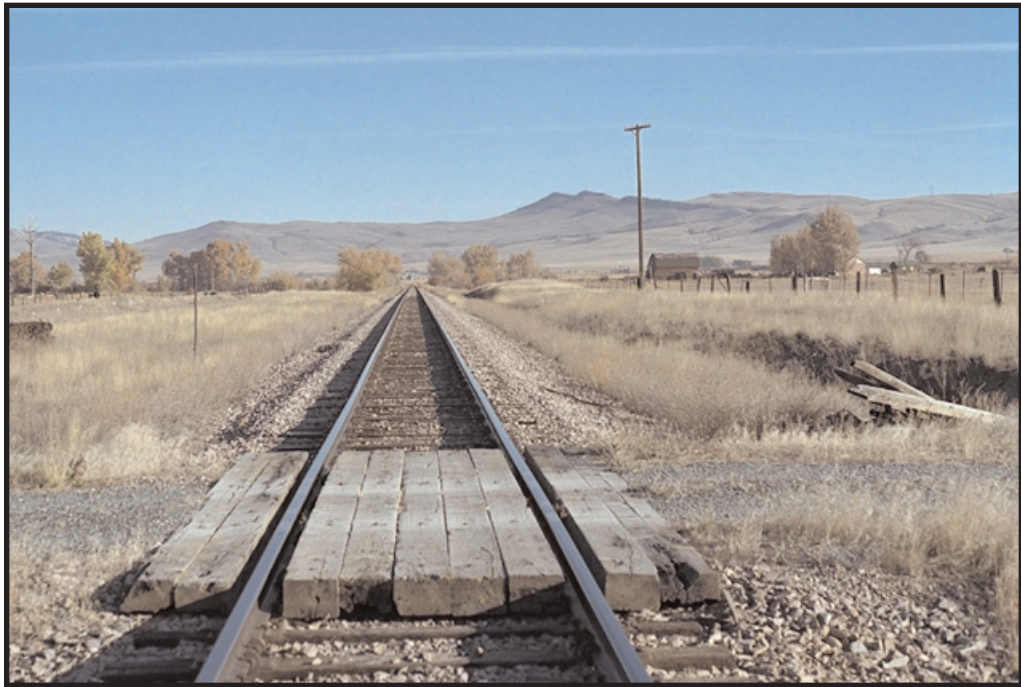
As mentioned above, there are only two at-grade road crossings of the railroad corridor, one located near the northern edge of the ranch which provides access to the sewage lagoons (see Photo 3-8-1); the other is located near the home ranch (see Photo 3-8-9).

Photo 3-8-9 : (H-04) An at-grade crossing along the Sewage Treatment Service Road.

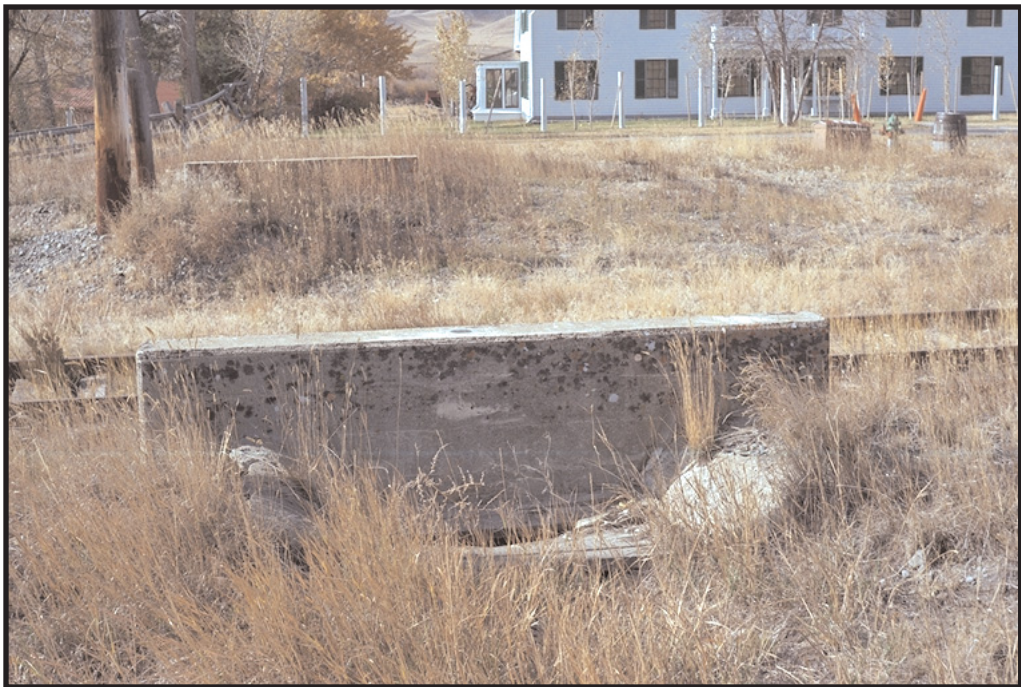
Photo 3-8-10 : (AD-21) Siphon (HS-57).

Located east of the main ranch house and on either side of the railroad tracks, the **Siphon** (HS-57), (see Photo 3-8-10) was built circa 1908 by the Chicago, Milwaukee, & St. Paul Railroad as part of the construction of the railroad track. No longer in use, the siphon consists of two poured-in-place concrete wells joined by a subterranean concrete tunnel that channels water under the railroad grade. The siphon was used to irrigate the main ranch house front yard and to provide stock water to Stallion Barn HS-16.

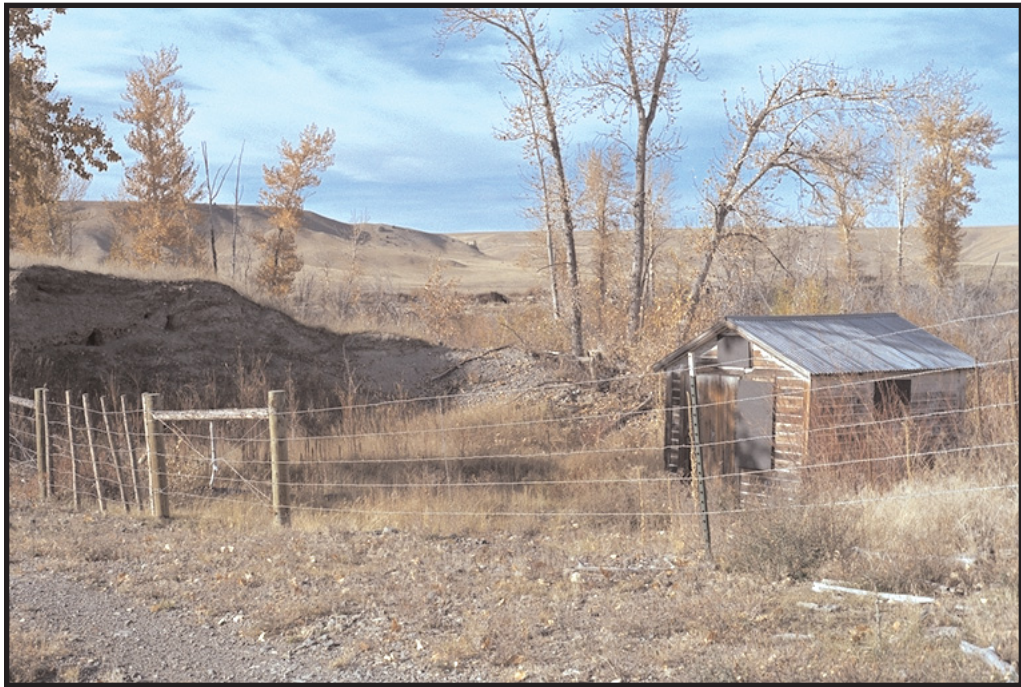
Photo 3-8-11 : (F-06) Pumphouse (HS-86).

A small **Pump House** (HS-86), (see Photo 3-8-11) is located in the northern pasture and on the north bank of the Kohrs-Manning Ditch. The pump house is a rectangular, one room structure with a gable roof. It is built on a concrete foundation with wood framing and the gable roof is covered with asphalt shingles. The roof is covered with corrugated metal sheets, which were added to the roof in 2000 by the NPS to protect the structure from further decay. A vertical plank door is located on the southern elevation as are two covered-over windows. A third covered window is found on the east elevation. A wetland surrounds the pump house and its outside piping systems are visible above the waterline. Built in 1960 by Con Warren, the structure is approximately 10 feet long by 8 feet high. It supplies water to the Front Field east of the railroad and north of the Warren Hereford Ranch complex.

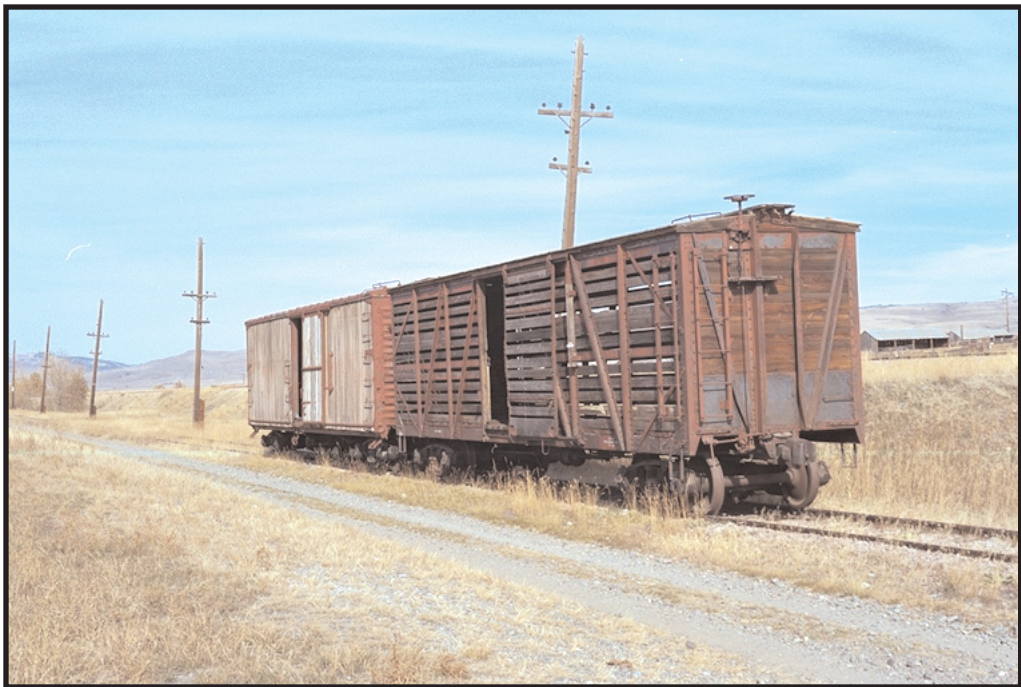
Photo 3-8-12 : (AD-19) Cattle Cars.

Two **Cattle Cars** (GRKO-970 and GRKO-862), (see Photo 3-8-12) are located on the inactive Milwaukee railroad tracks and across from the Bielenberg Barn. The 1920s-era cattle cars are red-stained, wood-frame, box-type cattle cars attached to a metal railroad-car deck, axles, and wheels. Cattle car GRKO-970 was built circa 1923 while GRKO-862 was built circa 1929; both cars were donated to the NPS in the 1980s from other parts of the country. These cattle cars are typical of those used during the Conrad Warren era.

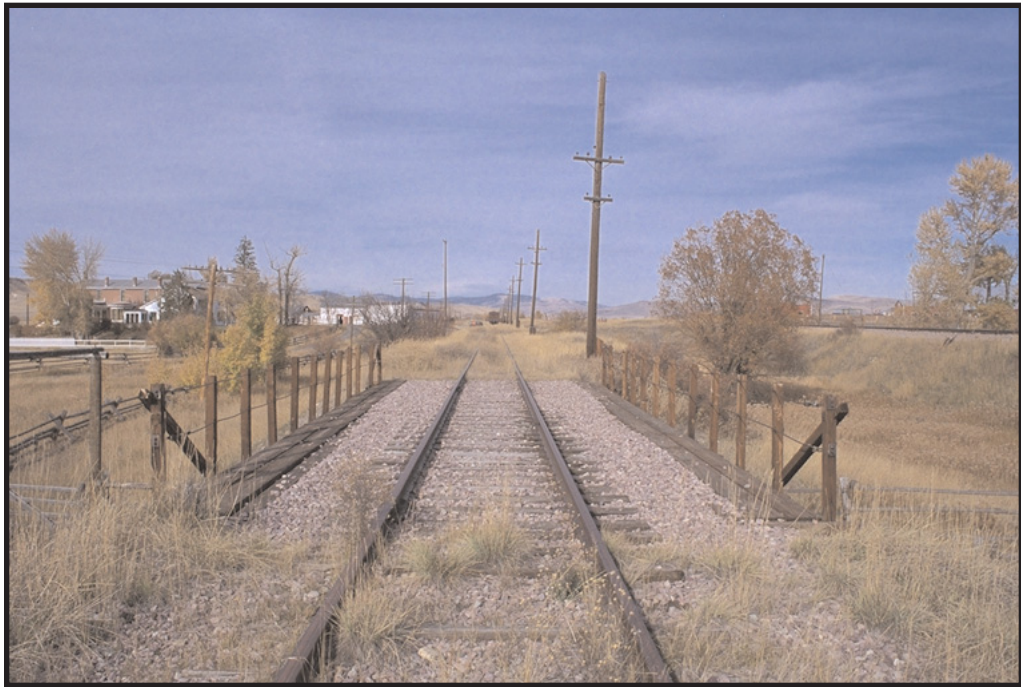
Two **railroad trestles** have been built to carry each of the railroad lines over the pedestrian underpass linking the visitor center with the rest of the ranch (see Photo 3-8-13). These trestles are supported by large wooden columns (approximately 10-12 inches in diameter) that support wooden beams and joists. Railroad track and ties are laid on top of wooden planking, and enclosed on the east and west sides by metal post and wire fencing. These overpasses are approximately 12 feet above the grade of the pedestrian trail.

Photo 3-8-13 : (RE-05) Railroad trestle above pedestrian underpass.

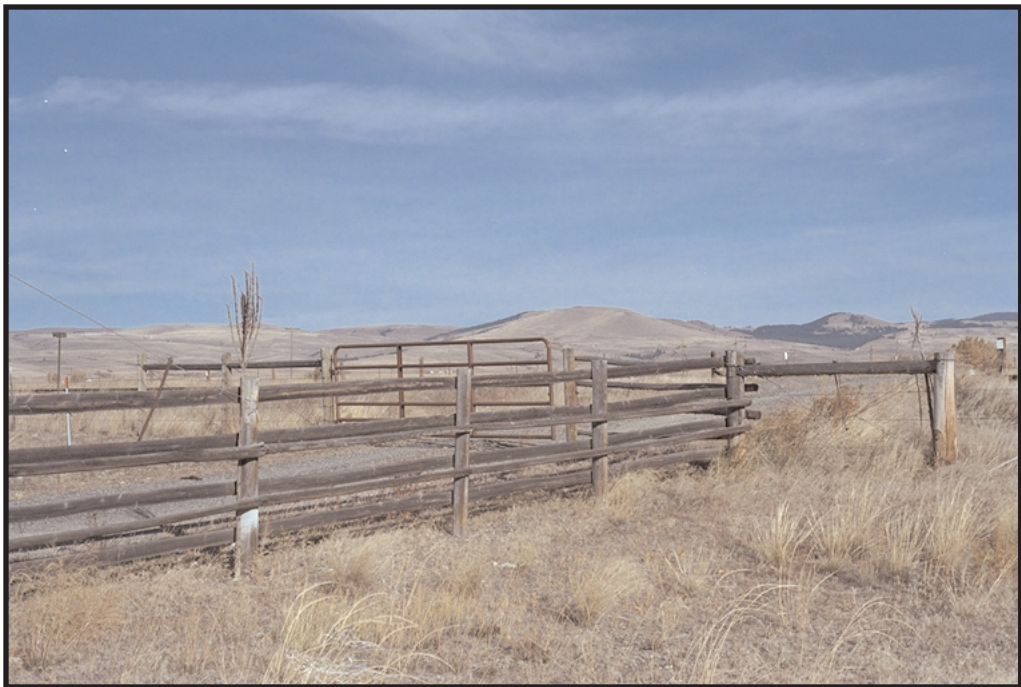
In the northern portion of the railroad corridor is a short section of **4-rail stacked-end fence**, (see Photo 3-8-14). Four split-log rails extend between log posts on one side of the fence while two more split-log rails are placed on the lower half of the fence on the other side. At each post, the rails for one section are stacked alternately with the rails for the next section, creating a stacked appearance.

The metal pipe gate consists of brown-painted, welded metal pipe frame filled with 4 pipe rails and 2 vertical pipe posts. The upper corners of the frame are rounded.

Photo 3-8-14 : (E-09) 4-Rail Stacked End Fence with Metal Pipe Gate.

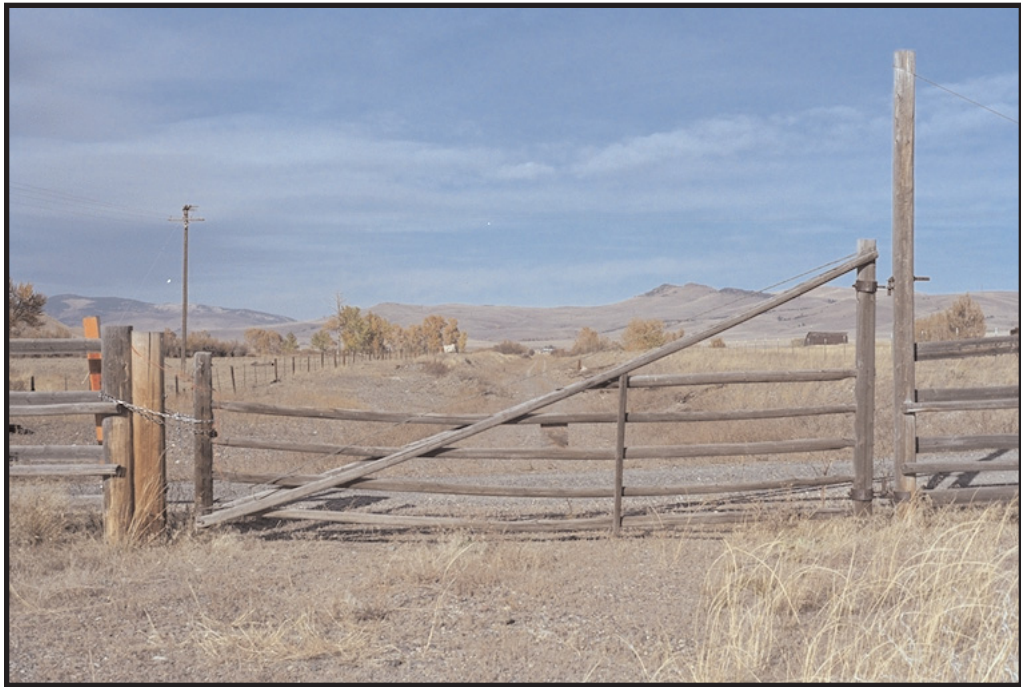
Three gate types are also located in the northern portion of the corridor: a **5-rail Braced Gate**, (see Photo 3-8-15) a **Galvanized Metal Gate**, (see Photo 3-8-16) and a **Metal Pipe Gate**, (see Photo 3-8-14). This gate has a hinge-post almost twice the height of the gate and has a long, diagonal brace leading from the top of the hinge-post to the opposite corner of the gate. This brace supposedly prevents and corrects sagging, although this gate is indeed sagging.

Photo 3-8-15 : (E-08) 5-Rail Braced Gate.

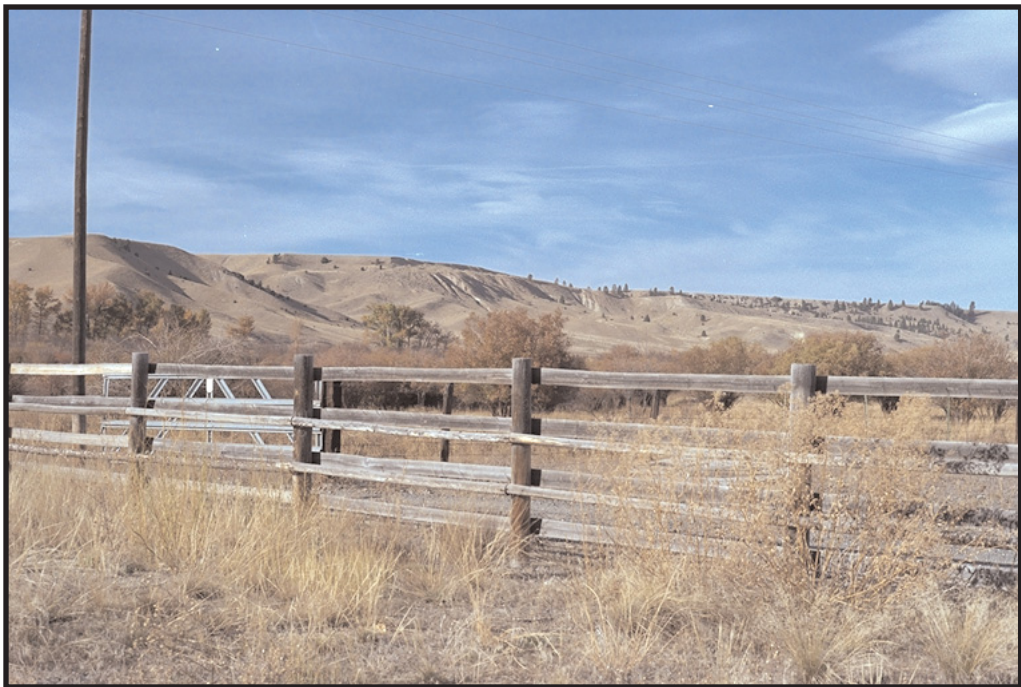
The galvanized metal gate has 5 horizontal metal rails and a vertical metal post at the center. Two diagonal metal braces are located on each side of the central post.

Photo 3-8-16 : (E-10) 4-Rail Locked End Gate with Galvanized Gate in background.

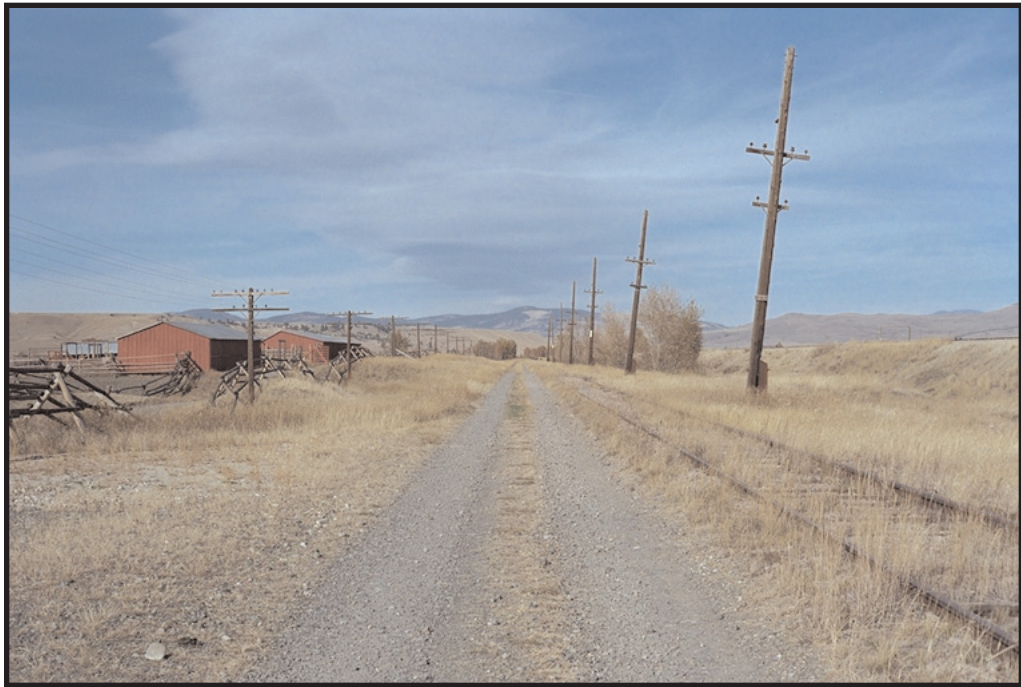
Two overhead utility lines run parallel to the railroad corridor. The remaining electric power lines and poles along the east side of the Milwaukee rail corridor are remnants of the once electrified railroad. Most of these have been removed, except for a small section near the Home Ranch complex (see Photo 3-8-17). The other set of poles runs along the west side of the Milwaukee corridor. While the poles are still standing and appear to be in poor condition, the electrical wires appear discontinuous and are downed in some areas. It is assumed that this line is no longer in service.

Photo 3-8-17 : (C-23) Overhead utility lines.

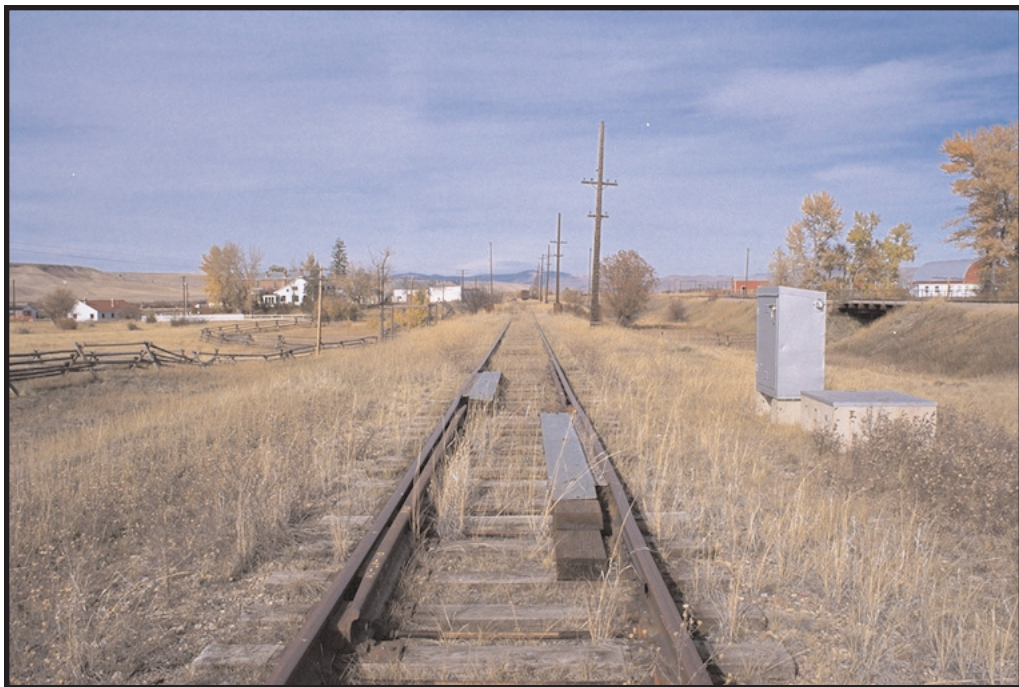
A **wheel flange detector** is located just south of the railroad trestles, along side the Milwaukee railroad line. It consists of a gray metal utility box and concrete box with wooden lid. Two metal plates are also located on the inside edges of the adjacent tracks (see Photo 3-8-18). This system was installed to measure vibration caused by the trains, and is no longer operational.

Photo 3-8-18 : (RE-10) Utility boxes with Wheel Flange Detector System.
